Project Name: Panama City Resort & Club Milestone Inspection

Consulting Engineer: MK Weber Structural Engineering

Reason for Inspection: 25-year Milestone Inspection as required by Florida State law

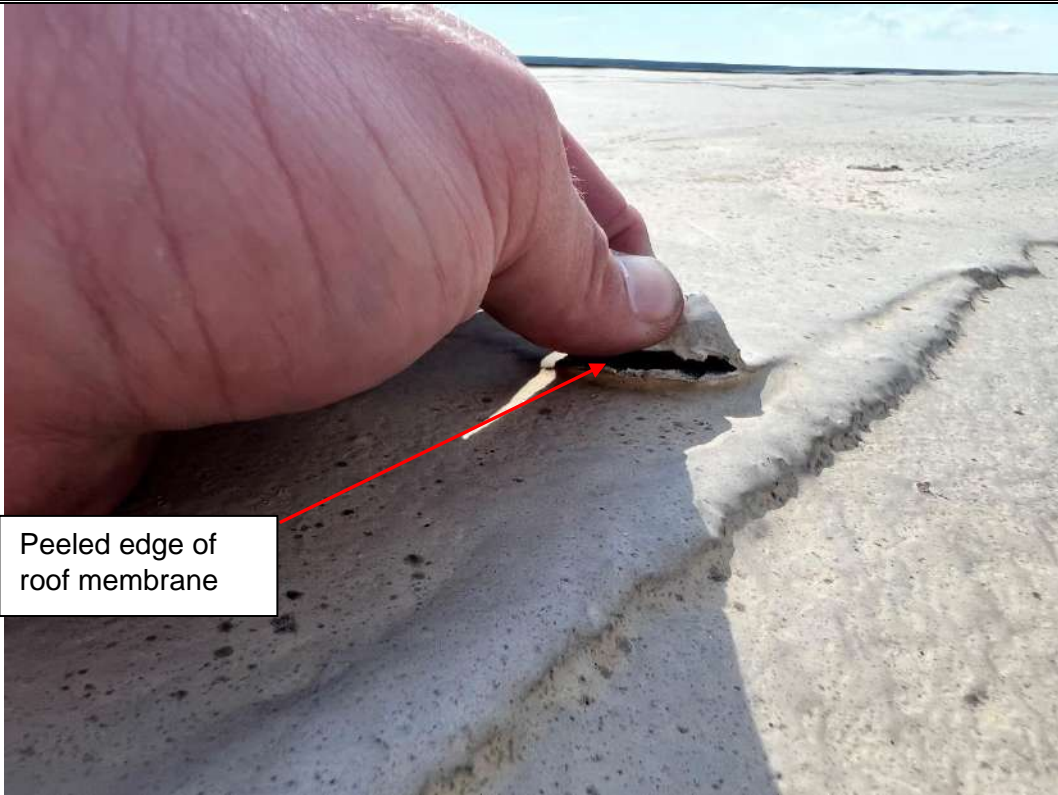
Photo 3

Peeled edge of roof membrane

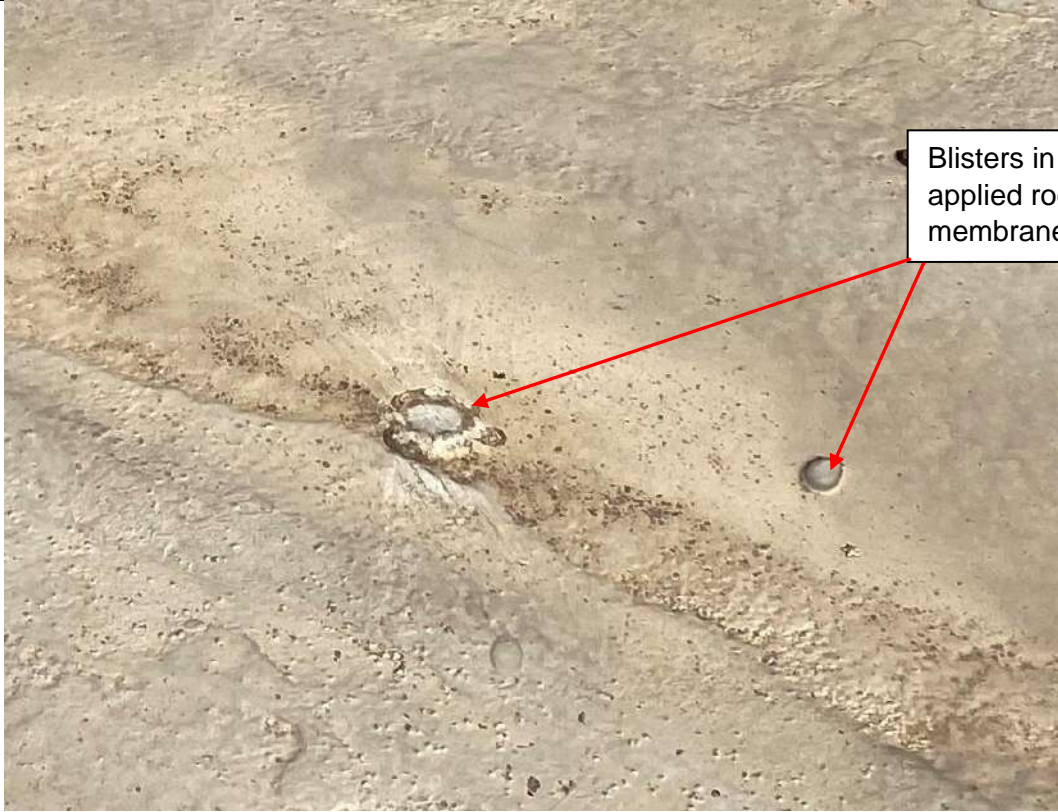
Photo 4

Blisters in liquid applied roof membrane

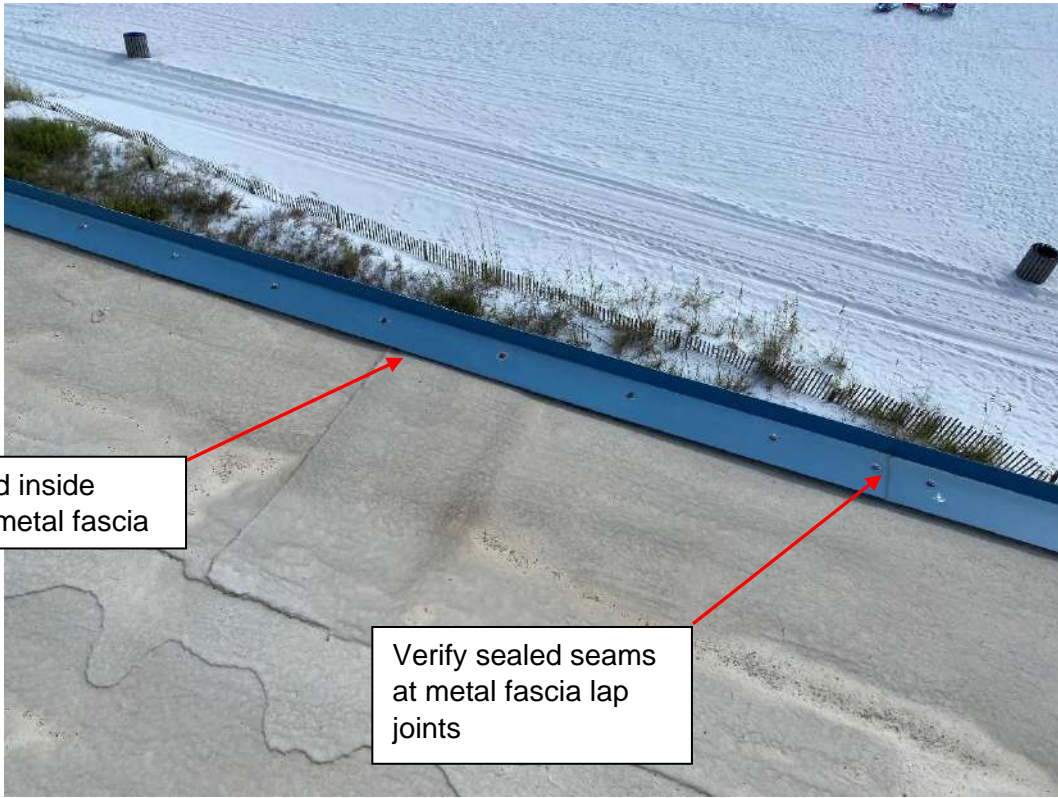
Photo 5

Unsealed inside edge at metal fascia

Verify sealed seams at metal fascia lap joints

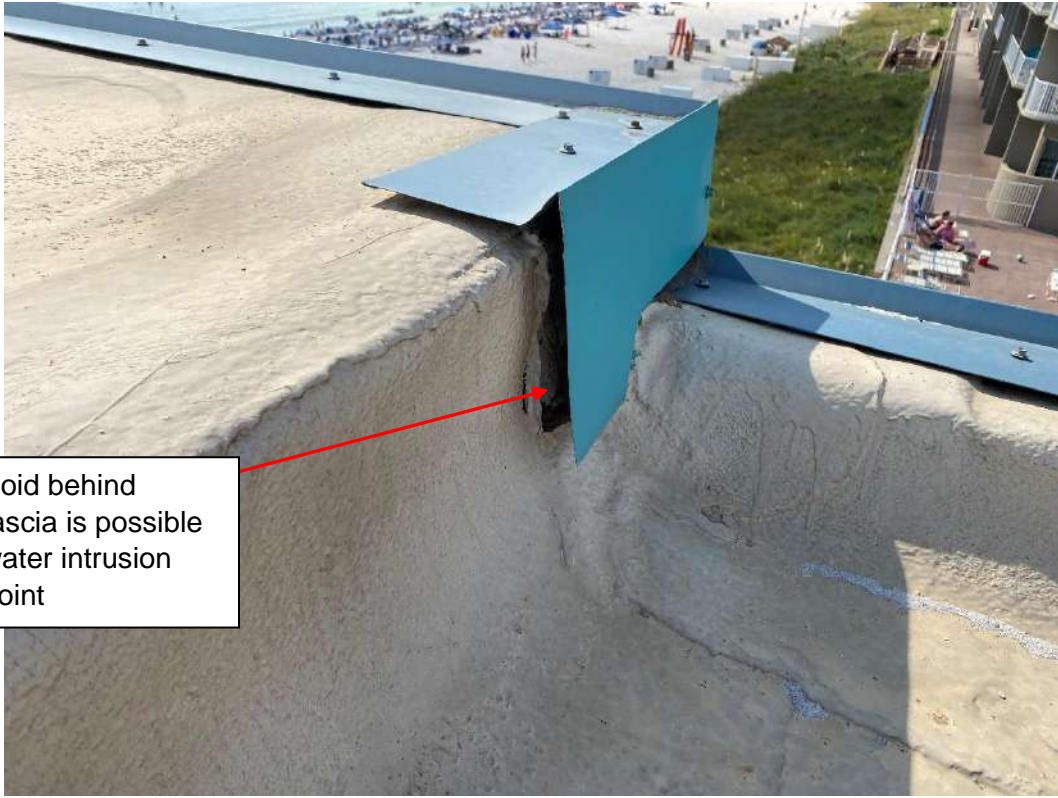
Photo 6

Observations & Cause		Required Repairs	Time-Frame	Photos
Roof	<ul style="list-style-type: none"> Some blisters and minor peeling in the roof membrane were found during the inspection of the roof. 	<ul style="list-style-type: none"> Clean the surface of the existing roof and apply another layer of liquid applied roof membrane. 	2yr	3-4
	<ul style="list-style-type: none"> There are several corroded fasteners at the metal fascia around the perimeter of the roof. Corrosion is likely due to exposure in the salt rich coastal environment. The inside edge of the fascia is not sealed over with the roof membrane. 	<ul style="list-style-type: none"> Replace all rusted fasteners with new #10 stainless steel gasketed metal roof panel fasteners. The inside edge of the fascia should be covered by a strip of roofing membrane. Verify that fascia is sealed at the overlapped seams. 	2yr	5-6
	<ul style="list-style-type: none"> There is a void behind the metal fascia at the western edge of the roof that could be a potential water intrusion point. 	<ul style="list-style-type: none"> Fasten the inside edge of the fascia return to the roof base. Cover the inside edge of the fascia with a strip of membrane roofing material. 	2yr	6

Void behind fascia is possible water intrusion point

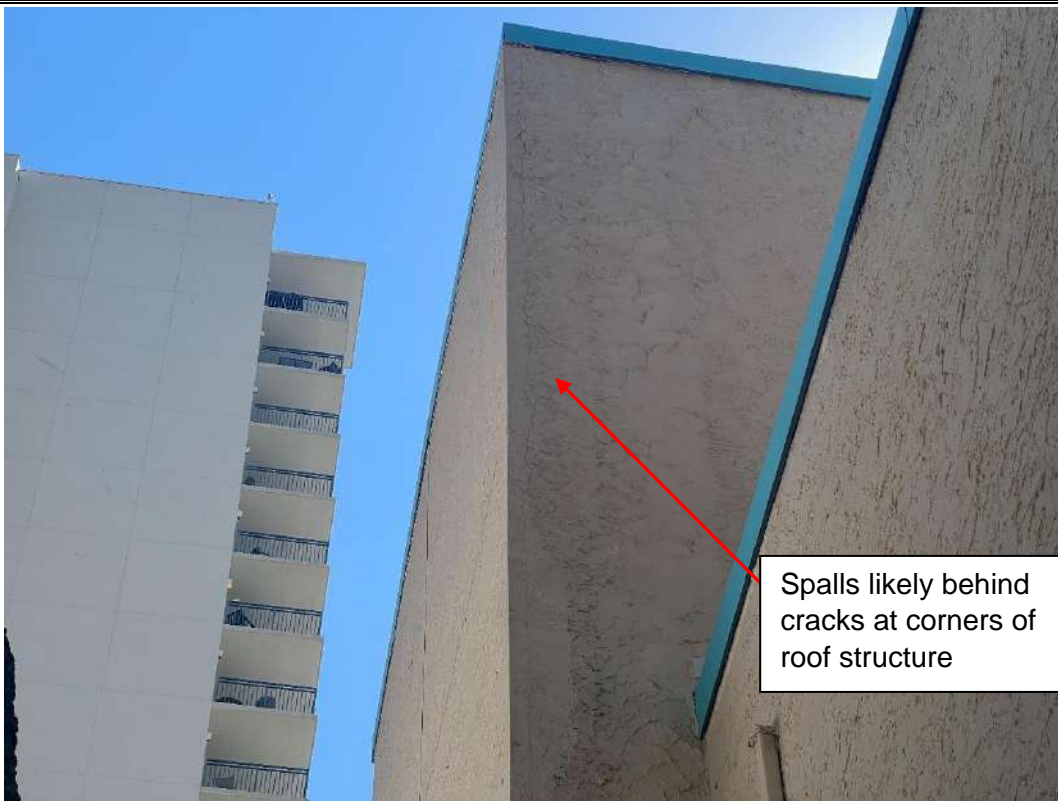
Photo 12

Observations & Cause	Required Repairs	Time-Frame	Phase II	Photos
Walls	<ul style="list-style-type: none"> The edges of the roof top structure have vertical cracks over the full height of the structure. The cracks in the stucco could be delamination of the stucco layer or an indication of spalled concrete behind the stucco layers. 	<ul style="list-style-type: none"> A section of the stucco will need to be removed to determine if the cracks stem from an underlying structural issue or defects in the stucco only. If damage is just at the stucco surface the loose stucco will need to be removed, patched, and recoated. If spalls are found, structural concrete repairs will be required. Engineered design and oversight are required for structure concrete repairs. 	1yr	N	9
	<ul style="list-style-type: none"> Cracks found at the edges of the masonry walls and at overhead beams and lintels are most likely the result of spalling concrete behind the stucco. When steel reinforcement in the CMU cells and concrete is exposed to the chlorides present in sea salt, the steel corrodes and increases the volume of the reinforcement resulting in cracks at the face of the masonry and concrete. Concrete spalls are caused by failure of the weatherproof coatings resulting in water intrusion and exposure to the salt rich coastal environment. 	<ul style="list-style-type: none"> All spall repairs must be repaired per ICRI Structural Concrete Repair specifications. See Appendix D Areas with less than 20% loss of reinforcing bar cross section, are to have all rust and scale removed and at least 1" of material removed beyond corroded reinforcement areas. Areas with loss of more than 20% of the reinforcing bar cross section will need to have additional reinforcement spliced to the existing reinforcement bars. 	1yr	N	11-13

Cracked masonry corner

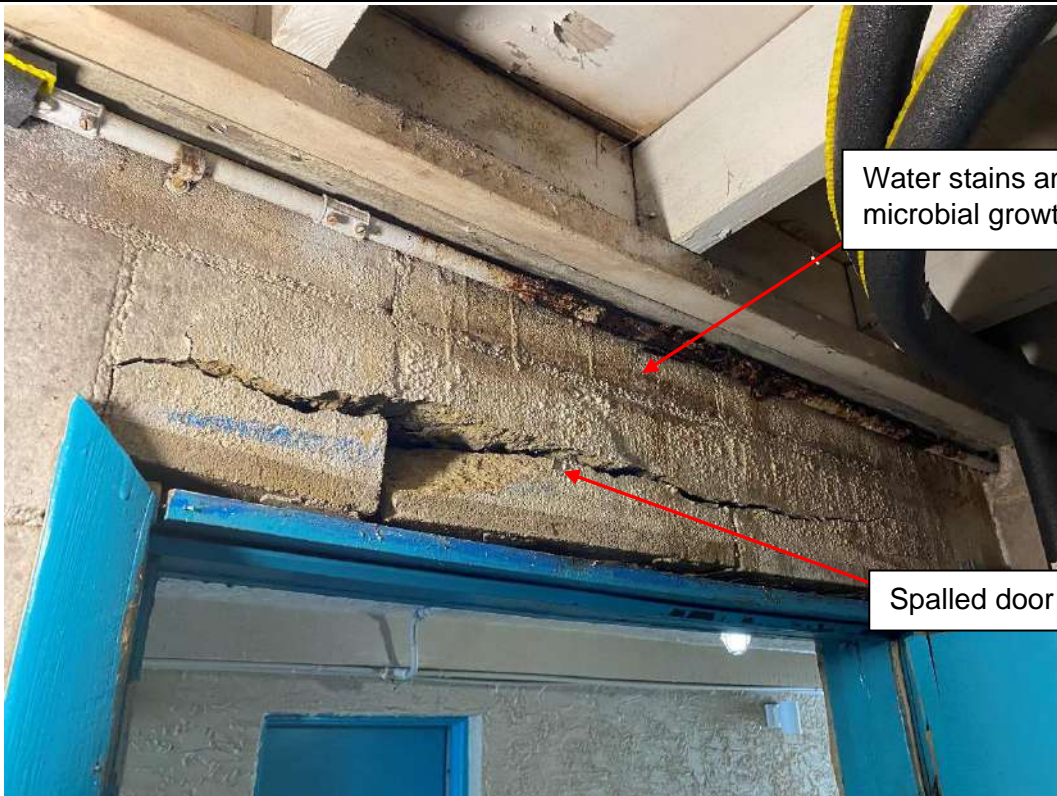
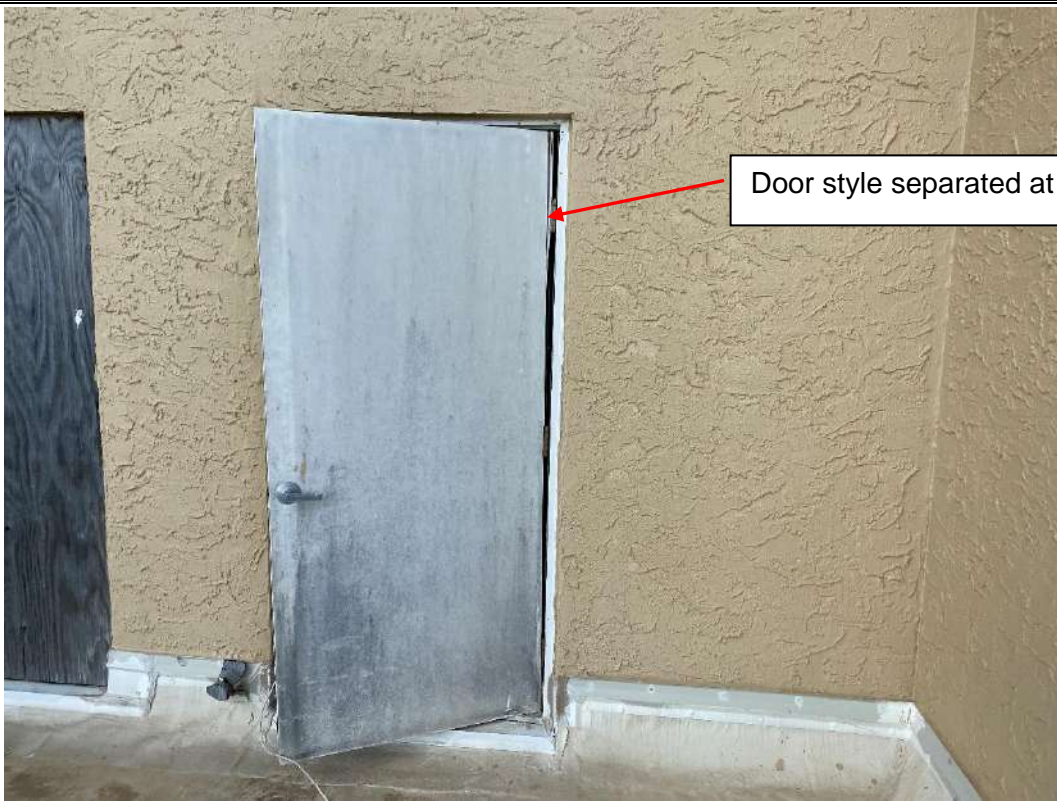
<ul style="list-style-type: none"> The door to the storage room on level 3 has separated from the door frame due to wood rot at the door and frame The masonry door header has a severe spall and there is risk of falling concrete. The issues at this storage room door are likely due to a water intrusion issue from the level above. 	<ul style="list-style-type: none"> Repair water intrusion issue at the level above the storage room door. Repair masonry spall per ICRI repair specification and engineered repair drawings. Replace door and door frame with a new fiberglass composite exterior door and stainless-steel hardware. 	ASAP	19-20
	<ul style="list-style-type: none"> The roof access door has water damage and has separated at the styles. This door has a severely weathered coating. There is another opening at the roof that is covered by a piece of plywood. This opening is subject to water intrusion as the perimeter of the plywood is not sealed. 	<ul style="list-style-type: none"> Replace door and door frame with a new fiberglass composite exterior door and stainless-steel hardware. 	1yr	21-22

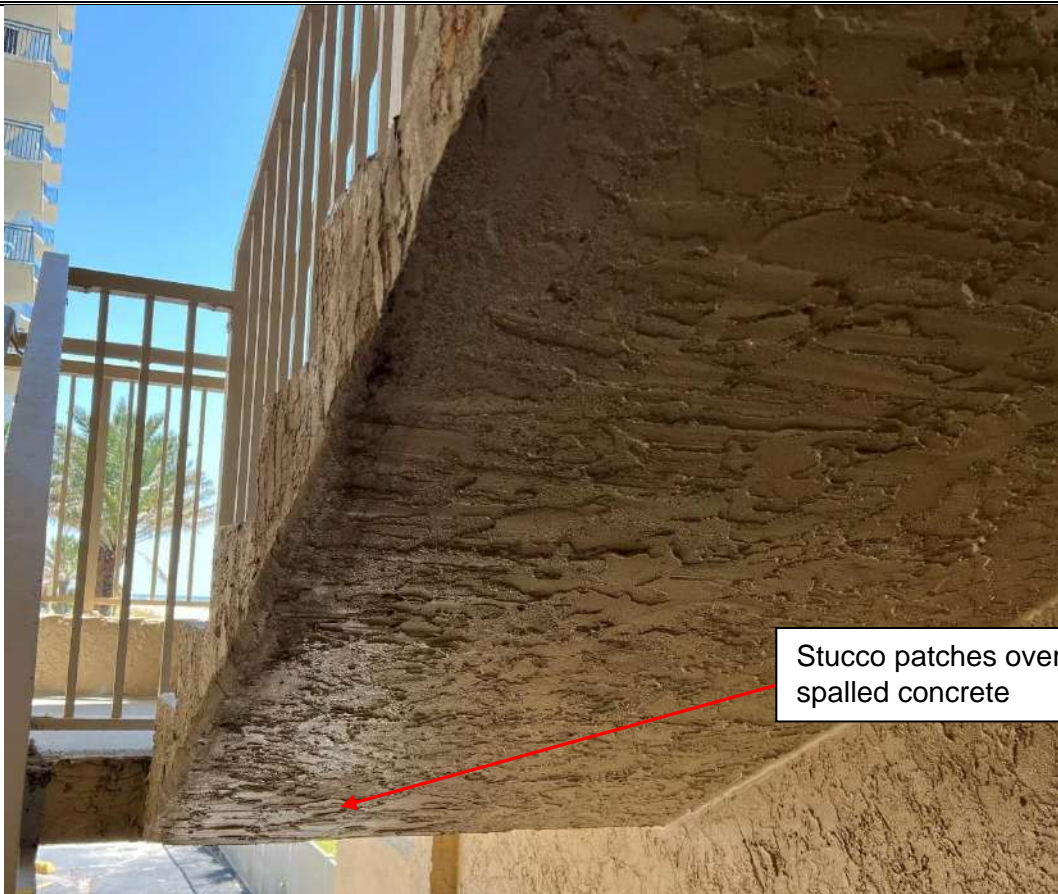
Photo 24

Stairwells	<ul style="list-style-type: none"> Several of the stair flights have spalls at the inside edges of the flights and at the transition to the landing. These spalls are due to water intrusion into the stairwell slabs. The steel reinforcement is bent at the bottom of the stair flights to splice into the landing slab. Rebar is prone to corrosion at the bends which is aggravated by water intrusion that migrates to the bottom of the stair flights and into the landing. 	<ul style="list-style-type: none"> Concrete spalls will need to be repaired per engineered details and specifications. Engineering oversight is required for verification of site conditions and preparation for repairs. 	2yrs	23-25
	<ul style="list-style-type: none"> The masonry walls surrounding the stairwells have some spalling at the steel reinforced edges and corners. Spalls at these locations could be due to water intrusion entering at the railing connections causing the corrosion at the steel reinforcement. 	<ul style="list-style-type: none"> Concrete spalls will need to be repaired per engineered details and specifications. Engineering oversight is required for verification of site conditions and preparation for repairs. 	2yrs	26

Painted over concrete spall

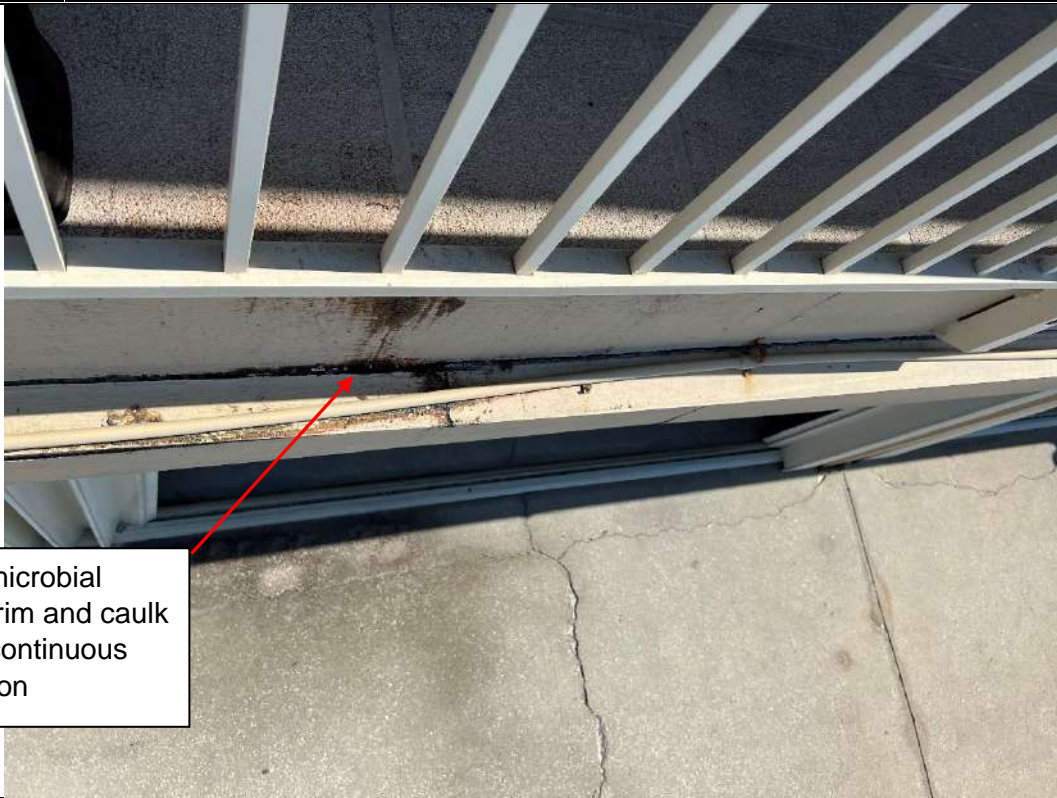
Photo 33

Balconies	<ul style="list-style-type: none"> • The balconies have variations in the amount of slope from the south wall and some are not level from east to west. • The western most porch has a 2” drop over four feet from one side to the other. • This variation indicates that there may have been some settlement in the wood balcony support structure. • Looking at the relatively small cracks in the trim, settlement appears to have been minimal since the install of the trim. • Most of the settlement likely occurred shortly after construction or during the undermining that occurred with Hurricane Opal. 	<ul style="list-style-type: none"> • A foundation specialist such as alpha foundations should be employed to stabilize the wood supports at the south side of the wood balcony structure. • Installation of helical piers can help to stabilize the post but cannot correct settlement that has occurred without the risk of further damage to the balcony structure. • The balconies would need to be rebuilt to correct the settlement. • Given the serviceable condition of the balconies, stabilization is the better option. 	2yrs	Y	36-37

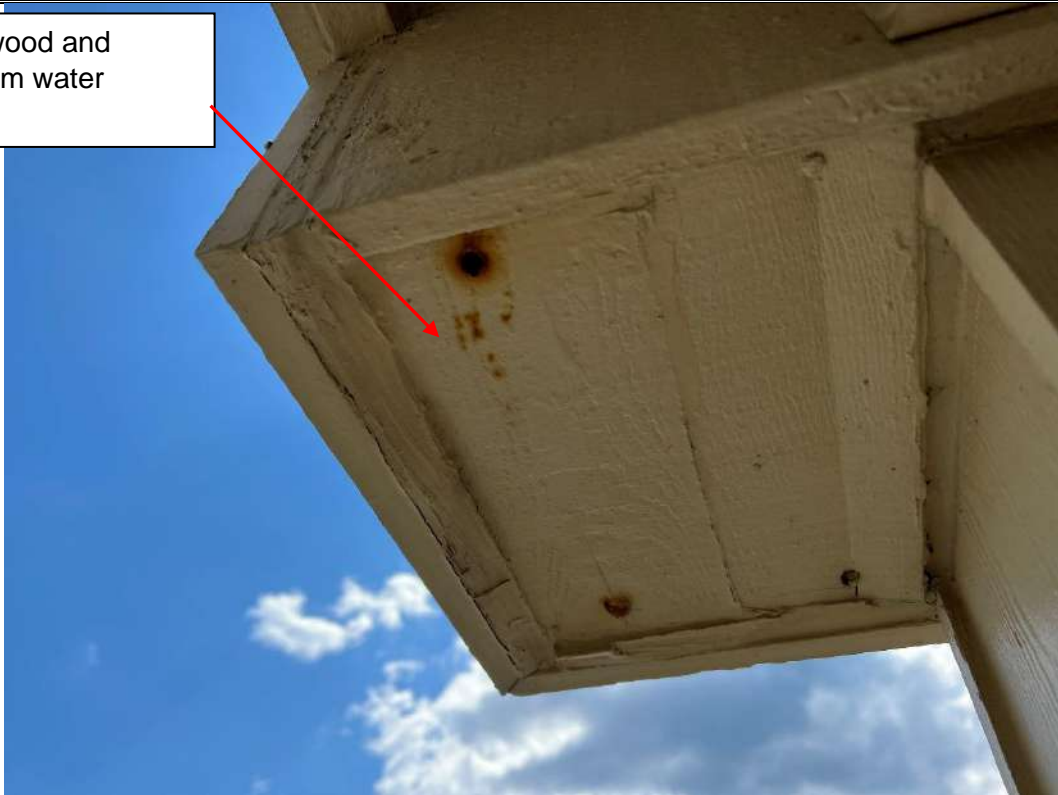
Photo 36

<ul style="list-style-type: none"> • There are some areas of deterioration and paint blisters at the wood trim wrap at the porch beams. • At the lower levels the areas of damage are likely from water intrusion at railing connections. • At the upper level the water intrusion is likely happening at the wall mounted fixtures and at the metal fascia attached at the roof deck above. 	<ul style="list-style-type: none"> • Make repair to the roof flashing mentioned in the roof section of the report. • Seal the edges of wall mounted fixtures to prevent water intrusion at the fasteners. 	2yrs	33-36
Flooring	<ul style="list-style-type: none"> • Some of the units have tiles that have separated from the subfloor. • A possible cause is that the tile simply was not well bonded to the mortar. • At areas near the south side of the units, it is likely that there are concrete spalls beneath the tile that have caused the separation. 	<ul style="list-style-type: none"> • Remove tile and resurface concrete surfaces. • If spalls are present, repair the concrete as directed in the engineered repair plans. • Replace flooring. • If replacing floors with new tile, note that tile requires a flexible membrane to prevent cracking with movement in the structure. 	5yrs	40

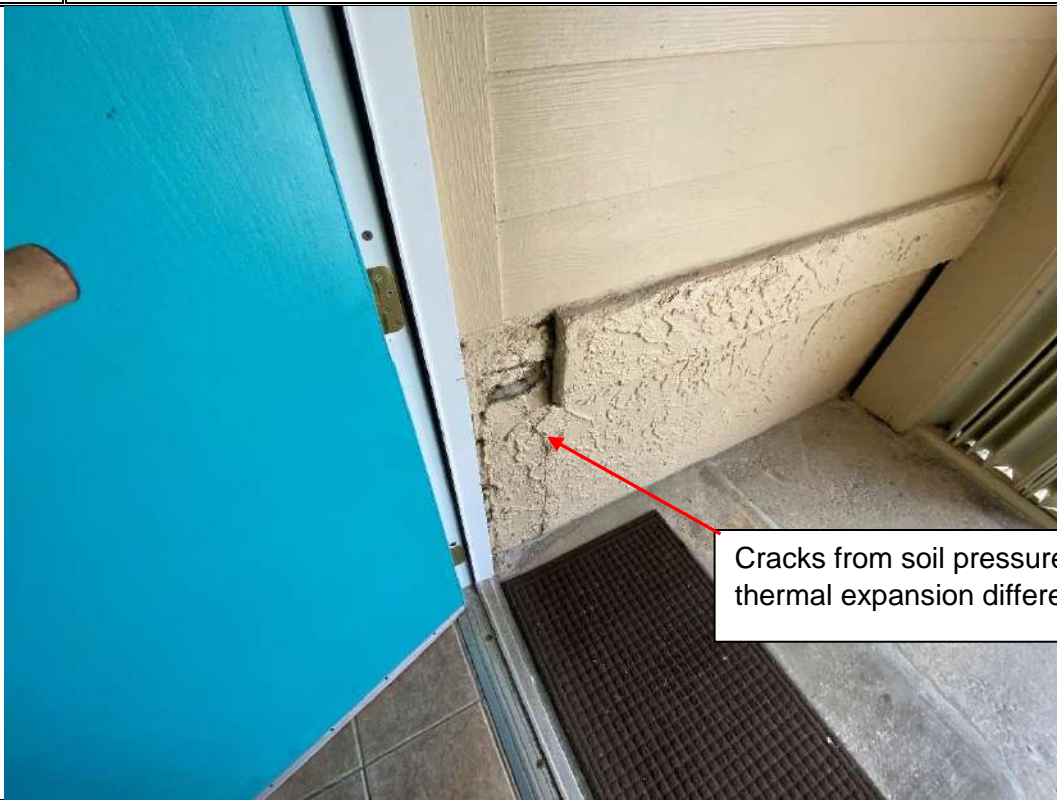
Photo 49

Cracks from soil pressure and thermal expansion differential

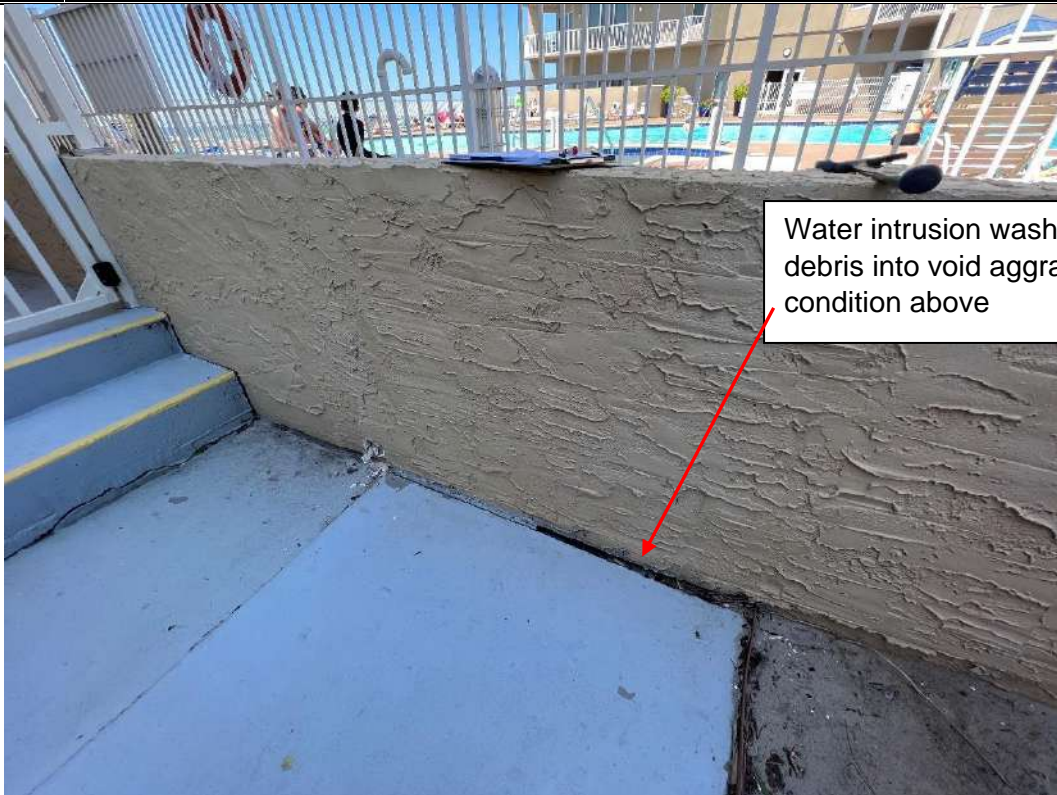
Photo 51

Walls	<ul style="list-style-type: none"> • Blisters in paint and cracks in drywall are signs of water intrusion in the walls. • Water is likely entering the walls from the AC units many of which show no signs of draining to the conduit or decks. 	<ul style="list-style-type: none"> • Remove damaged drywall or paneling and replace any water damaged framing or insulation found. • Install flashing at AC wall penetrations. • Replace wall panels with new drywall. 	2yrs	43-45
Retaining Walls	<ul style="list-style-type: none"> • Storm water funneling into openings and carrying sediment coupled with seasonal thermal expansion has resulted in cracks at retaining walls has damaged the concrete. 	<ul style="list-style-type: none"> • Clean out cracks between walkways and retaining walls. • Install a backer rod and seal cracks with a polyurethane sealant. • Repair cracks in retaining walls. 	2yrs	47-50
Mechanical Space	<ul style="list-style-type: none"> • The ceilings in the mechanical space have several spalls and areas of microbial growth likely caused by water intrusion at the deck level above. 	<ul style="list-style-type: none"> • Repair or install waterproof coatings at the floors above damaged areas. • Repair concrete spalls with Sika VOH after proper preparation of the damaged areas. 	2yrs	51-52

Spall at edge of previous repair
